Service Bulletin

SB #:	002
Date:	30/10/23

Title: Deltajet 500 BMW gearbox propeller shaft rear oil seal and roller bearing

Applicable to Aircraft: (include any specific restrictions, hours, serial numbers etc.)
All BMW-powered DeltaJet 500 StingRay aircraft

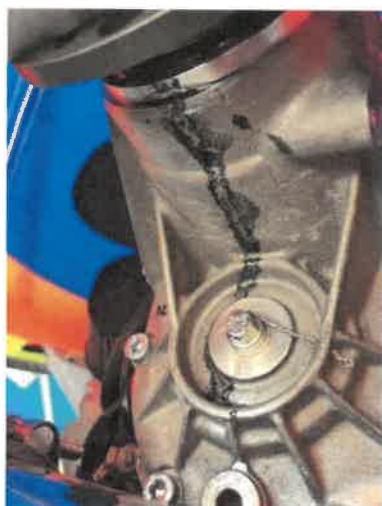
Inspection of another BMW-powered DeltaJet 500 StingRay (approx. 10 hours flight time that had not been flown for some days) showed a clearly visible oil leak emanating from the rear oil seal and tracking downwards across the aluminium gearbox casing (Fig. 1). Again, when the propeller was held firmly, a small amount of lateral play was found.

Fig. 1 External oil leak

Loss of oil over an extended period will lead to damage to the gearbox and possible failure in flight.

- All owners should inspect their gearbox and inform Flylight Airsports if an oil leak is present as shown in Fig. 1 above.
- Even if no oil leak is present, all owners should check for any lateral movement of the prop shaft as it exits the gearbox and inform Flylight Airsports if found.
- All pilots should add these checks to their preflight inspection and inform Flylight Airsports if either an oil leak or lateral movement of the prop shaft develops.
- If either an oil leak or lateral movement is present the aircraft must not be flown.

For all units found to have either an oil leak or lateral play, replacement oil seals and any other internal parts that may be found to have been affected will be supplied and fitted.

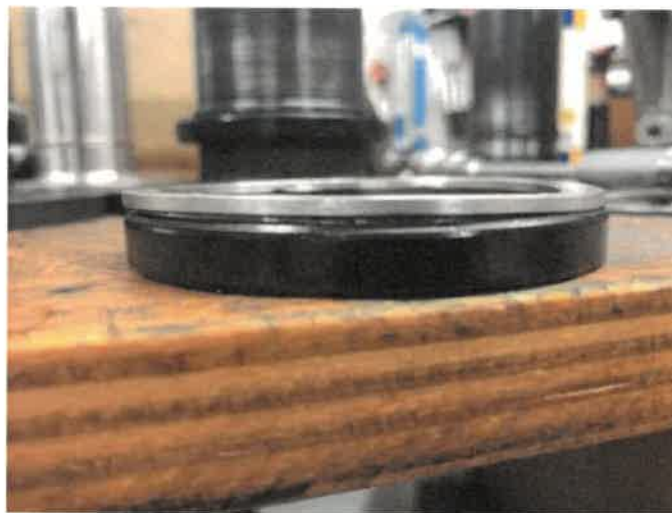
Fig. 2 oil seal and retaining ring

When the first gearbox was stripped down and the oil seal removed, it was found that the inner metal retaining ring did not fit properly into the rubber oil seal (Fig. 2). The metal retaining ring is like a 'top hat' and should fit inside an internal groove in the oil seal. This is the probable cause of the oil leak noticed, although it does not appear to affect all gearboxes.

Enquiries with the gearbox manufacturer (TakeOff-ul, Germany) found that it had received a new batch of oil seals from their supplier in early 2023 with no mention of a design change. A new type of metal retaining ring designed to fit the current oil seal has been manufactured and is now fitted to all new gearboxes. The change was also adopted for gearboxes already in TakeOff's stock, which were disassembled and re-manufactured with new oil seals and retaining rings. However, a small number of gearboxes appear to have been fitted to the BMW engine before the change in the oil seal was noticed, and therefore they have the old retaining ring design with the new oil seal design, resulting in an oil leak.
